Mockingbird Pedestrian Update (30%)

Thursday, September 3, 2015

Initial Site Visit

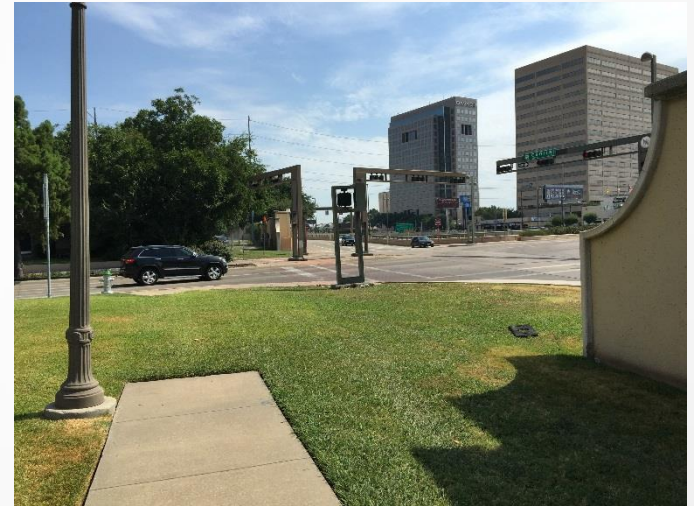
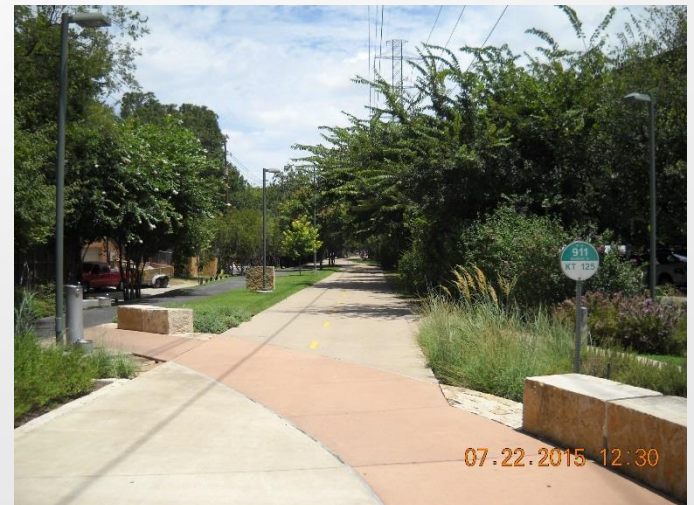
- Completed
 - Wednesday, July 22, 2015
 - Monday, August 3, 2015
 - Tuesday, August 4, 2015
- Goals
 - Observe Existing Conditions
 - Complete Signal Inventory
 - Complete Sight Distance Evaluation at existing conditions

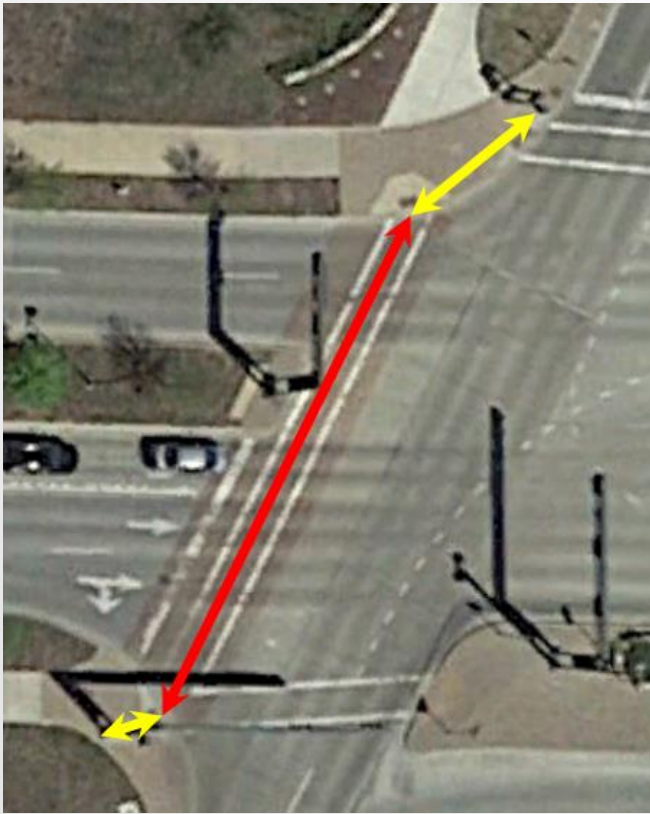
Pedestrian Clearance Times

The time allocated for the “walk” and “don’t walk” movements. Pedestrian clearance times are calculated to allow a pedestrian to push the button and walk from the button to the edge of the opposing roadway.

- Upgrade all push buttons to 2" accessible pedestrian push buttons
- Relocate push buttons as necessary to meet MUTCD standards
- Upgrade all pedestrian signal heads to countdown heads
- Evaluate phasing opportunities and pedestrian clearance times
- Consider passive detection options

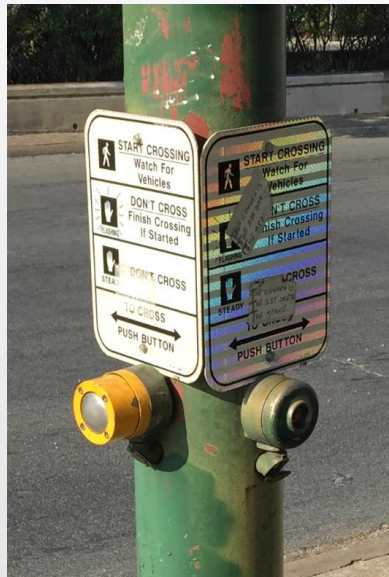
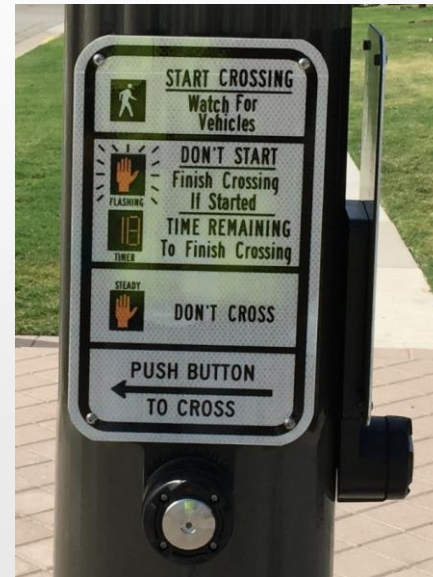
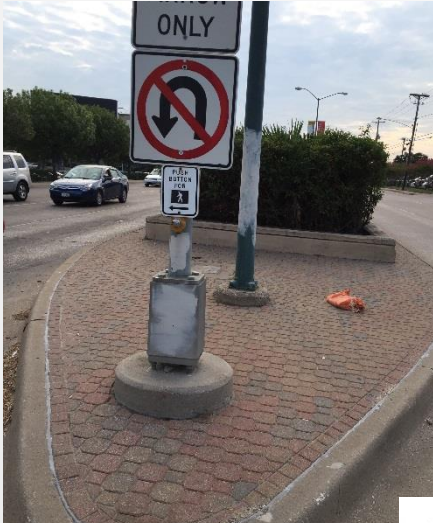
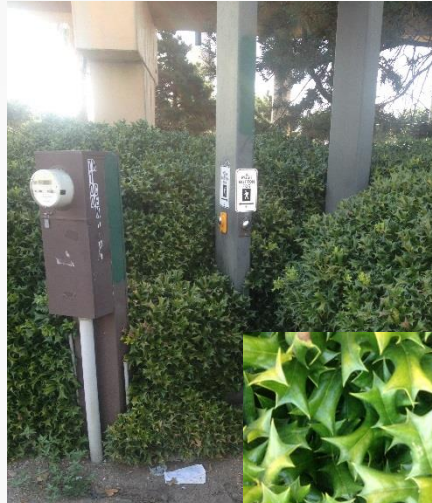
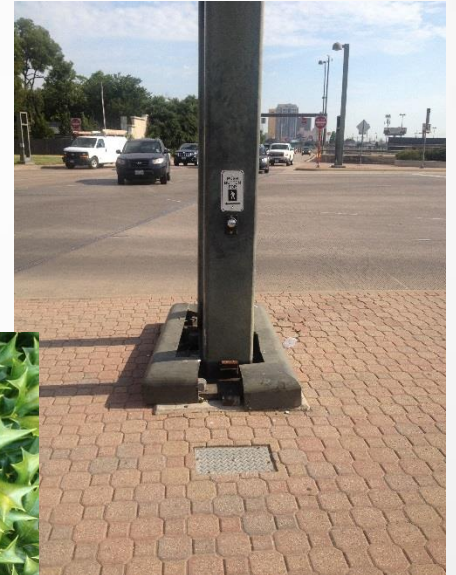
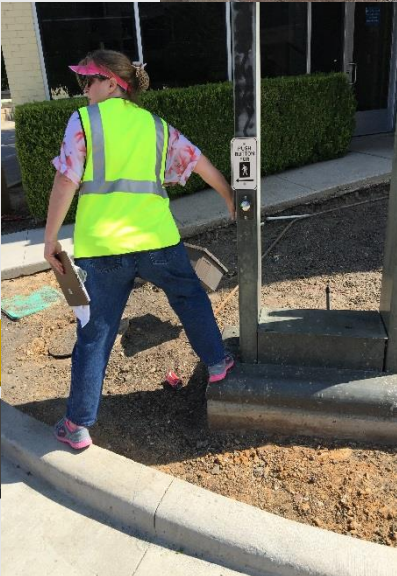
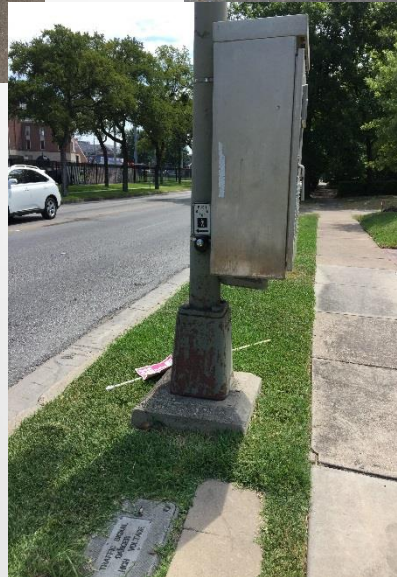
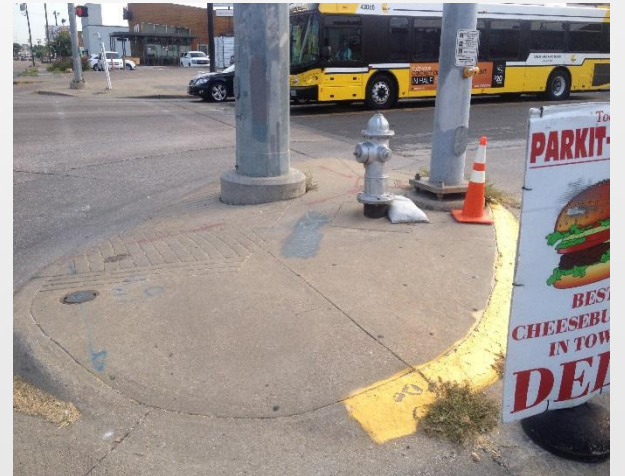
Location

- Does it have a detector?
- Where is the detector located?
- Is it accessible?
- What type of detector does it have?
- Does it meet current standards?

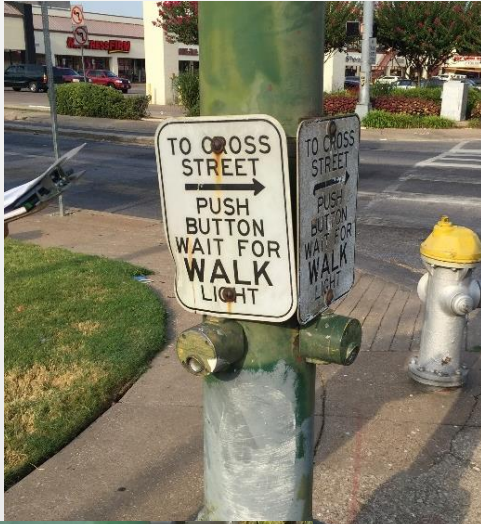
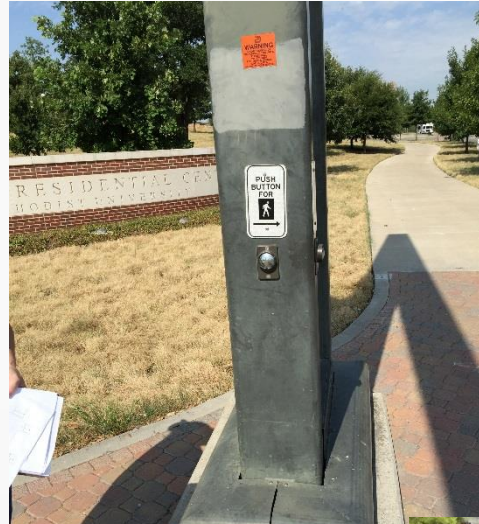
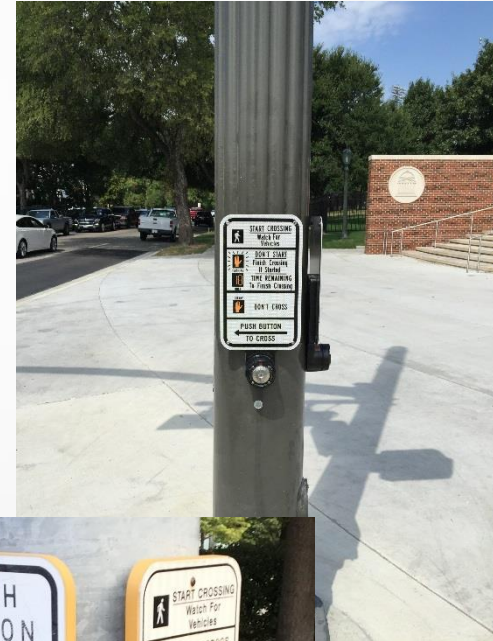
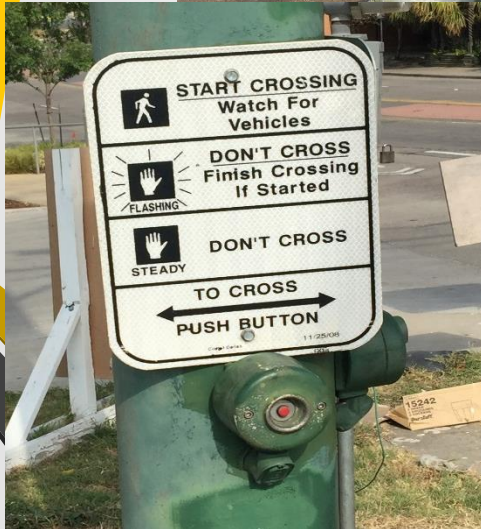
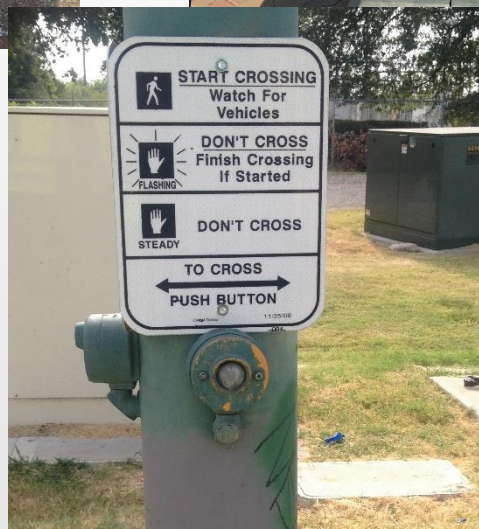
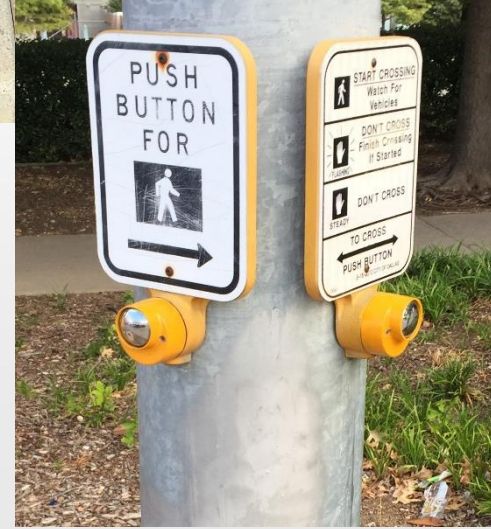
Type

Push Button - Ideal (APS)	8

Push Button - Meets 2 inch Standard	86

Push Button - Does Not Meet 2 inch Standard	10

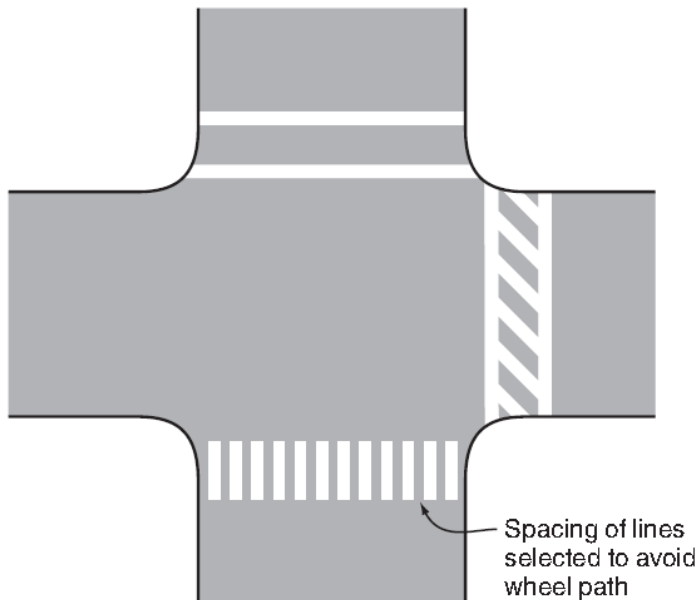
Figure 3B-19. Examples of Crosswalk Markings

- Does every signalized intersection have crosswalks?
- Where is it located?
- What type crosswalk is it?
 - Transverse
 - Diagonal
 - Longitudinal

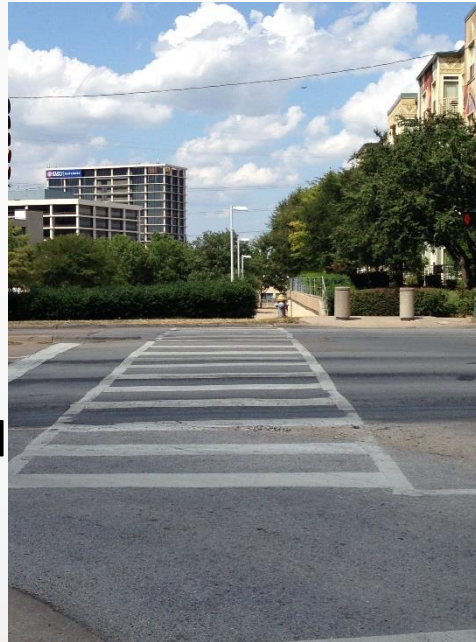
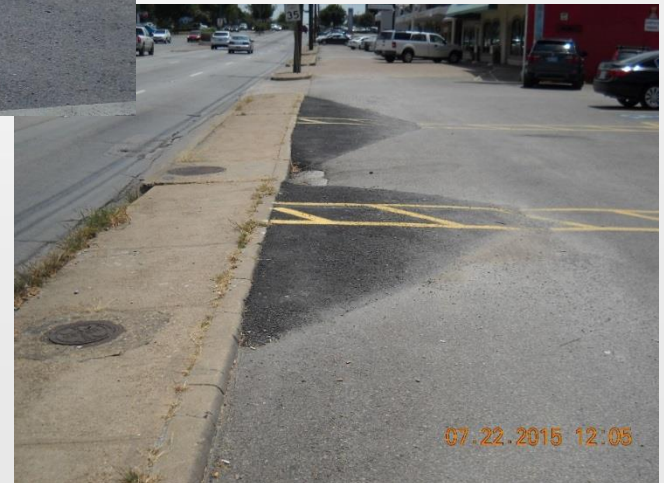
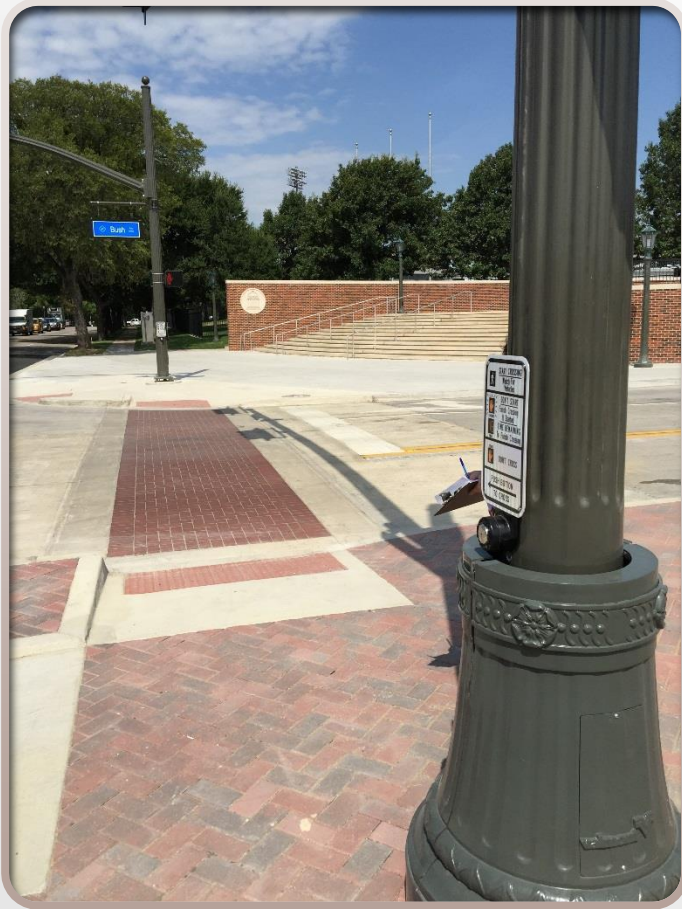
Curb Ramps

- Does each approach have an ADA ramp?
- Where is it located?
- Does it align with crosswalk?
- Does it have a detectable surface?
- Does it meet current standards?
 - Correct slope
 - Correct width

- Remove existing vegetation from sidewalks
- Repair broken sidewalks
- Upgrade directional ramps to current standards
- Enhance bicycle accommodations on streets and at intersection
- Widen sidewalks
- Consolidate driveways

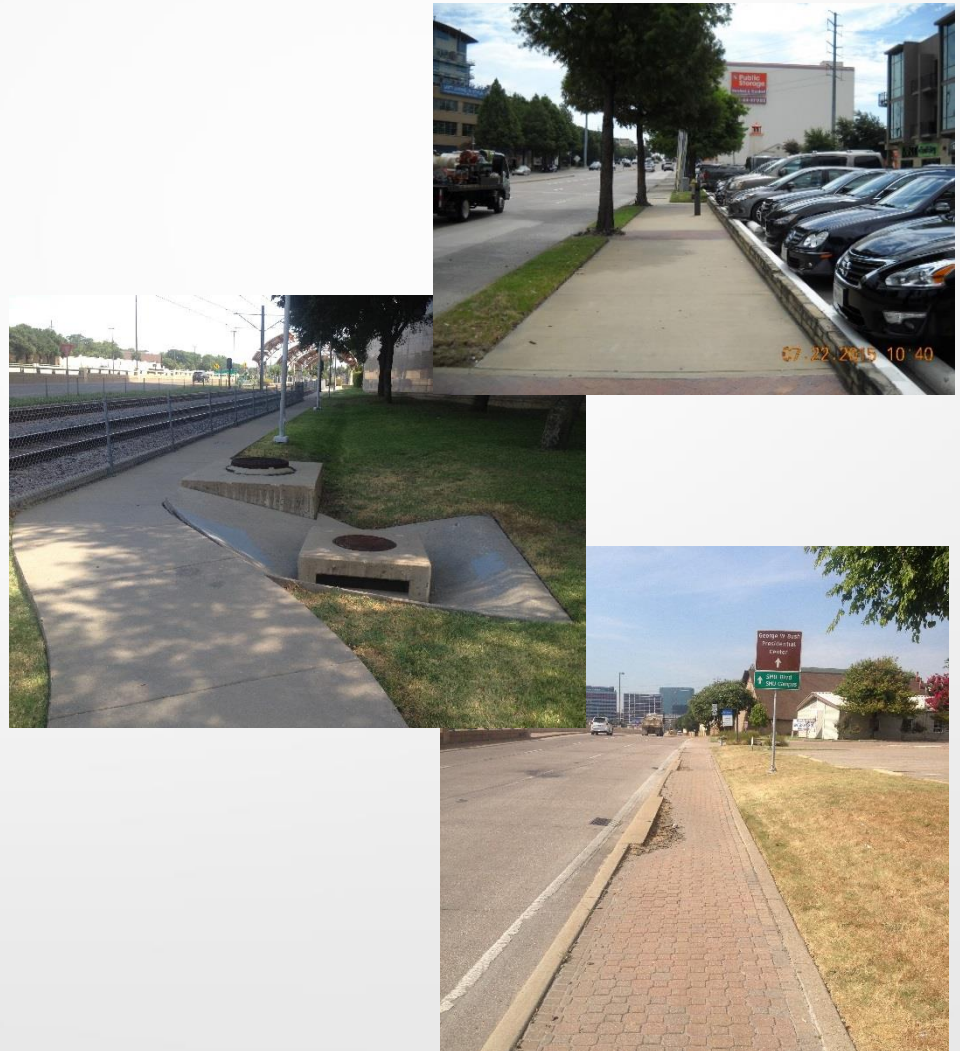
Sidewalks

- Does the sidewalk maintain a minimum of 4 feet?
- If narrow, is there a passing zone?
- Does it have a planting strip?
- Is it clear of obstructions?
- What is width?
- Is it continuous?
- What is anticipated pedestrian volume?

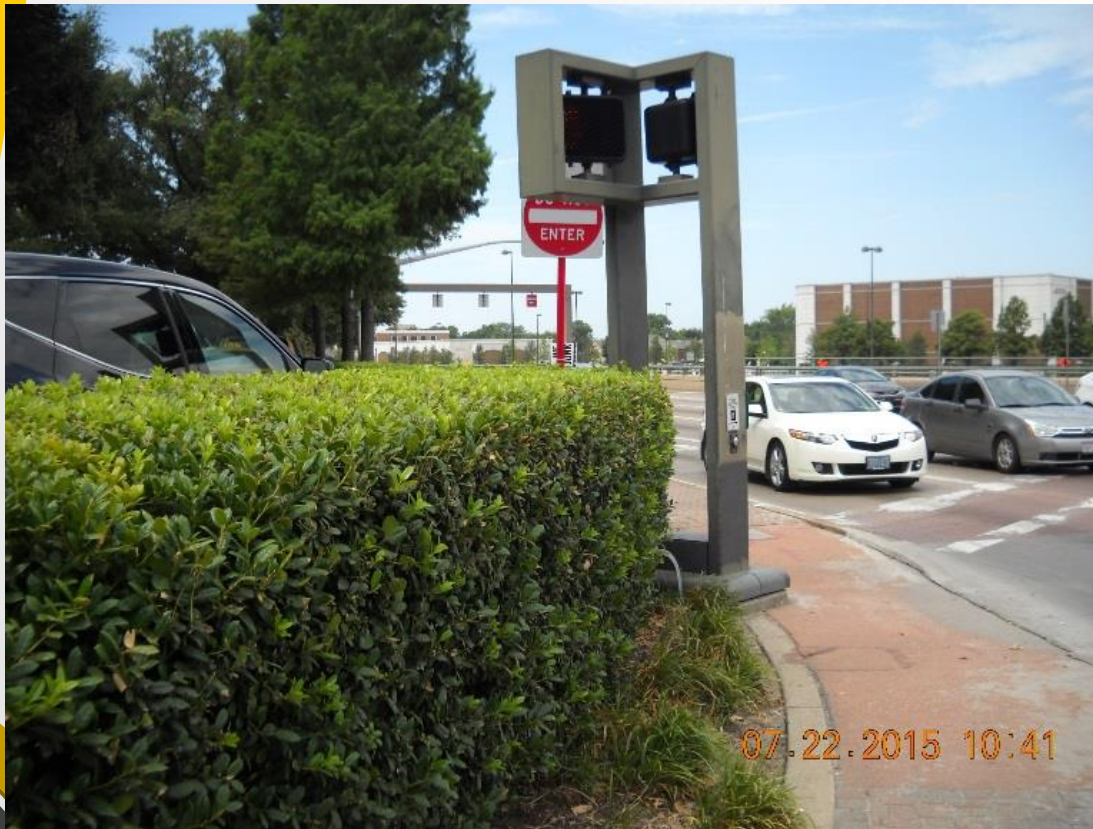
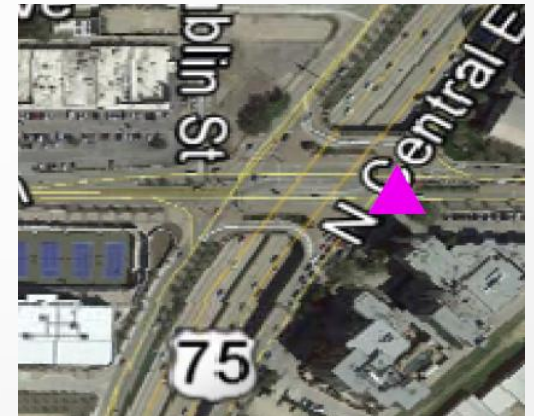
US 75 Northbound Frontage Road and Mockingbird Pedestrian Crossing

Pedestrian Viewpoint

- 10/2014

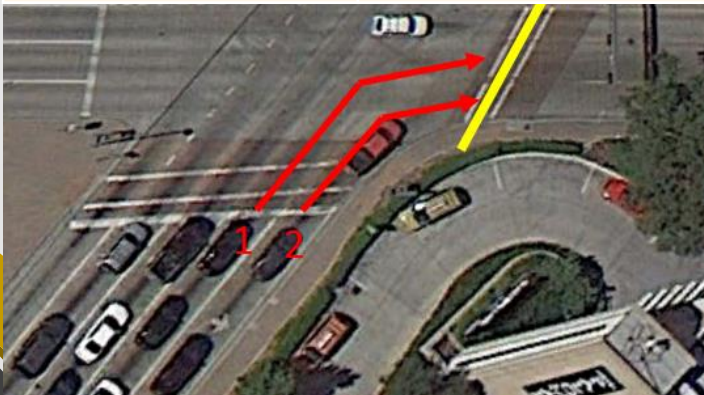
Vehicular Viewpoint

Design Speed	Sight Distance Design (ft)
15	80
20	115
25	155
30	200
35	250
40	305
45	360
50	495

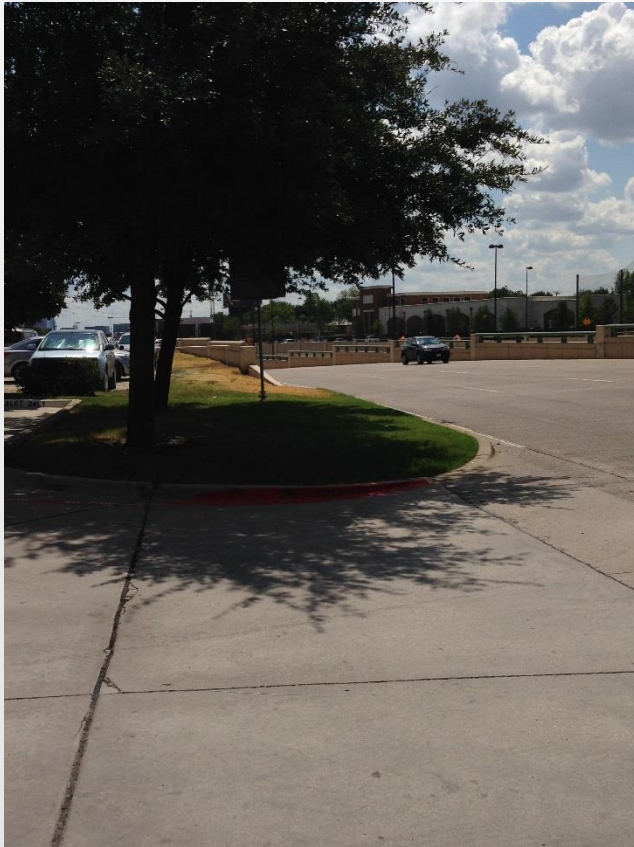
Major Roadway	US 75 NBFR
Intersecting Roadway	HR driveway
Posted Speed Limit	35 mph (frontage road)
Design Vehicle	Passenger Car
Required Intersection Sight Distance	335'
Available Sight Distance	~150'

- Identified Obstacles
 - Retaining Wall
 - Speed of traffic
- Possible Solutions
 - Close driveway
 - Remove or modify retaining wall
